INSTALLATION RESTORATION PROGRAM /
PHASE I: RECORDS SEARCH,
BUCKLEY AIR NATIONAL GUARD BASE
AURORA, COLORADO.

Buckley Air National Guard Base Aurora, Colorado

Simons, Li & Associates, Inc. P.O. Box 1816 Fort Collins, Colorado 80522

August 31, 1982

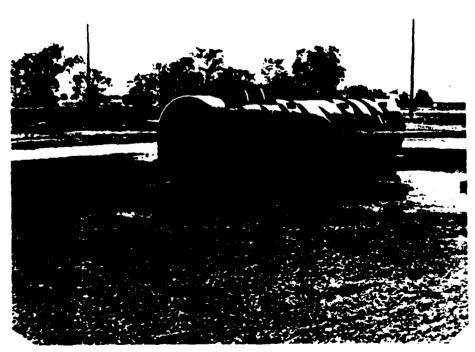
FIGURE F.3. FIRE TRAINING AREA NO. 3

- 4. Fire Training Area No. 3 has a moderate potential for migration of contaminants. The site is used for training exercises by the fire department. Contaminated fuels and possibly waste solvents have been burned in the area. The pit is unlined and is within 1,000 feet of the installation boundary. FTA No. 3 received a HARM score of 61.
